Manhole Inspection Summary

Manhole # S23II_036MH

Insp Date: **10/9/07 8:48 AM**

Location Address: **1637 GILMOR ST**

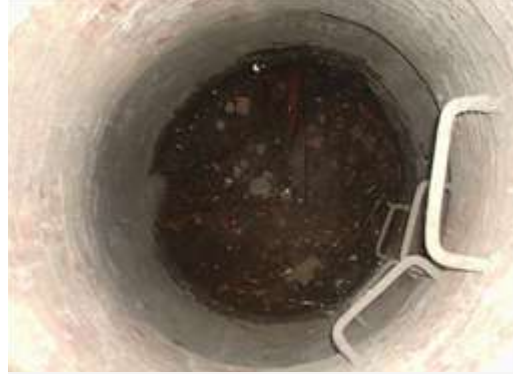
Top View

Bench and Channel debris.

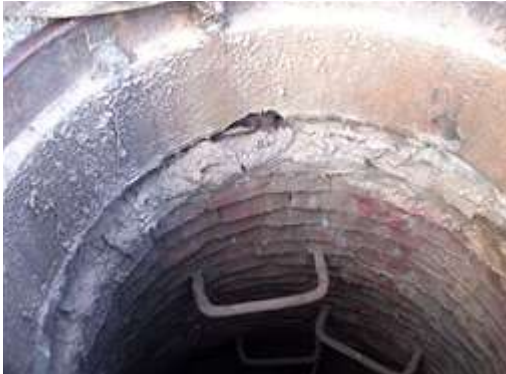
Defect

Frame leaks. Frame offset. Adjustment deterioration and infiltration. Barrel infiltration - other side.

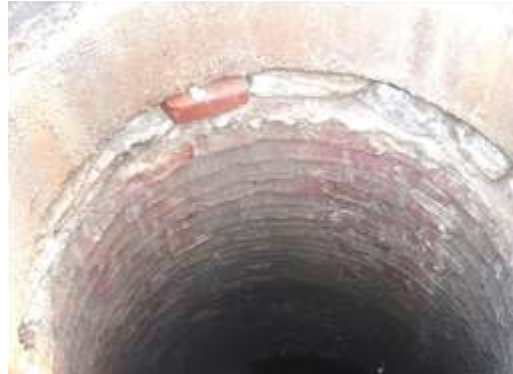
Defect

Frame leaks. Adjustment deterioration, loose brick and infiltration. Barrel infiltration.

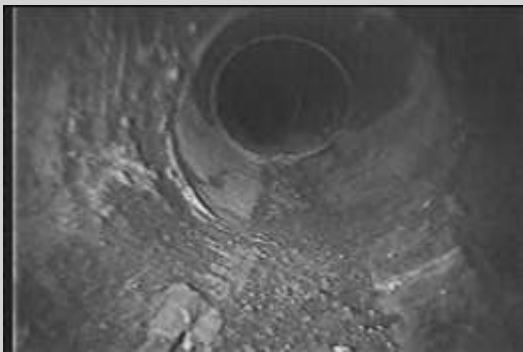
8 in. Circular Gravity Sewer Pipe Out @ 12 O'Clock

Pipe Material: **Clay** ☐ Pipe Lined

Invert Depth: **9.75** (ft.) Flow Characteristics: **None**

Infiltration: **None** Pipe Seal Cond: **Unknown**

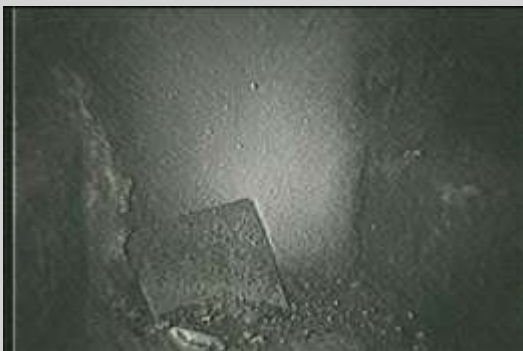
Pipe In @ 9 O'Clock

Connects To: **Stub connection / abandoned**
